ANNUAL REPORT FOR 2005

Marks Creek Mitigation Site
Wake County
WBS Element 34455.4.2
TIP No. R-2547WM

Prepared By:
Natural Environment Unit & Roadside Environmental Unit
North Carolina Department of Transportation
December 2005

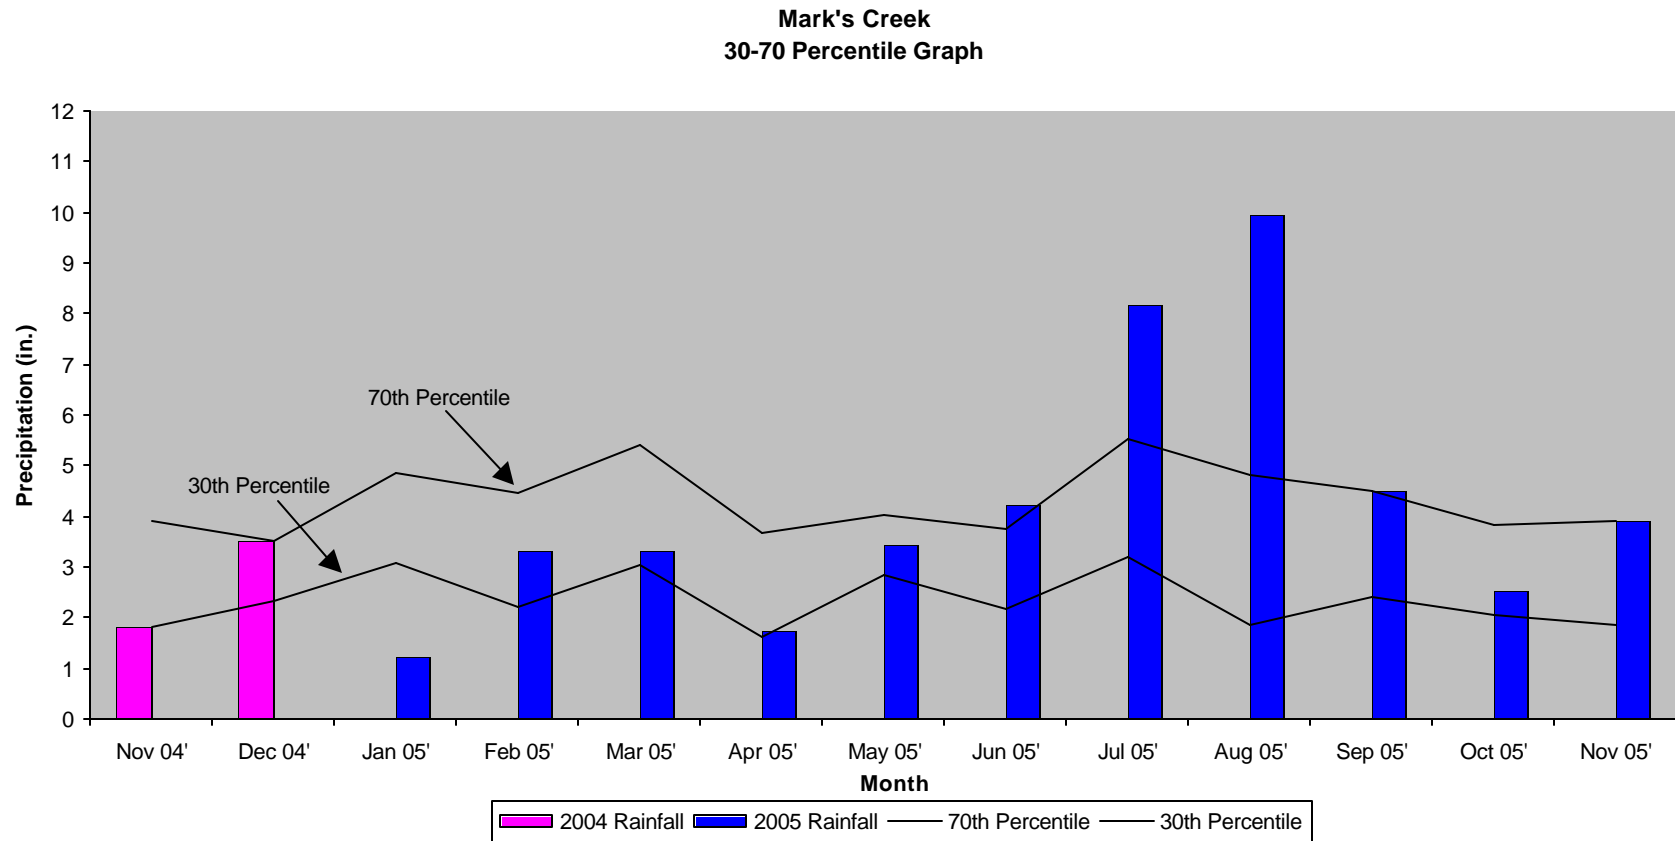
FIGURE 4. 30-70 Percentile Graph

Figure 4 provides an examination of the local climate in comparison with historical data in order to determine whether 2005 was “average” in terms of climate conditions. The two lines represent the 30th and 70th percentiles of monthly precipitation for Raleigh. The bars are the monthly rainfall totals for November 2004 through November 2005. The NC State Climate Office collected the historical data for the Raleigh/Durham weather station.

Months with below average rainfall include December (04'), January, February, March, May, June, and September. November (04'), April, August, October, and November experienced average rainfall. The month of July experienced above average rainfall for the year. Overall the site experienced average rainfall in 2005.
